### FINAL DESIGN

**Eagle Zinc OU1 Site**

**TECHNICAL PLAN FOR THE DEMOLITION  
OF BUILDINGS AT THE FORMER EAGLE ZINC FACILITY**

**EAGLE ZINC SITE OPERABLE UNIT 1  
Hillsboro, Illinois**

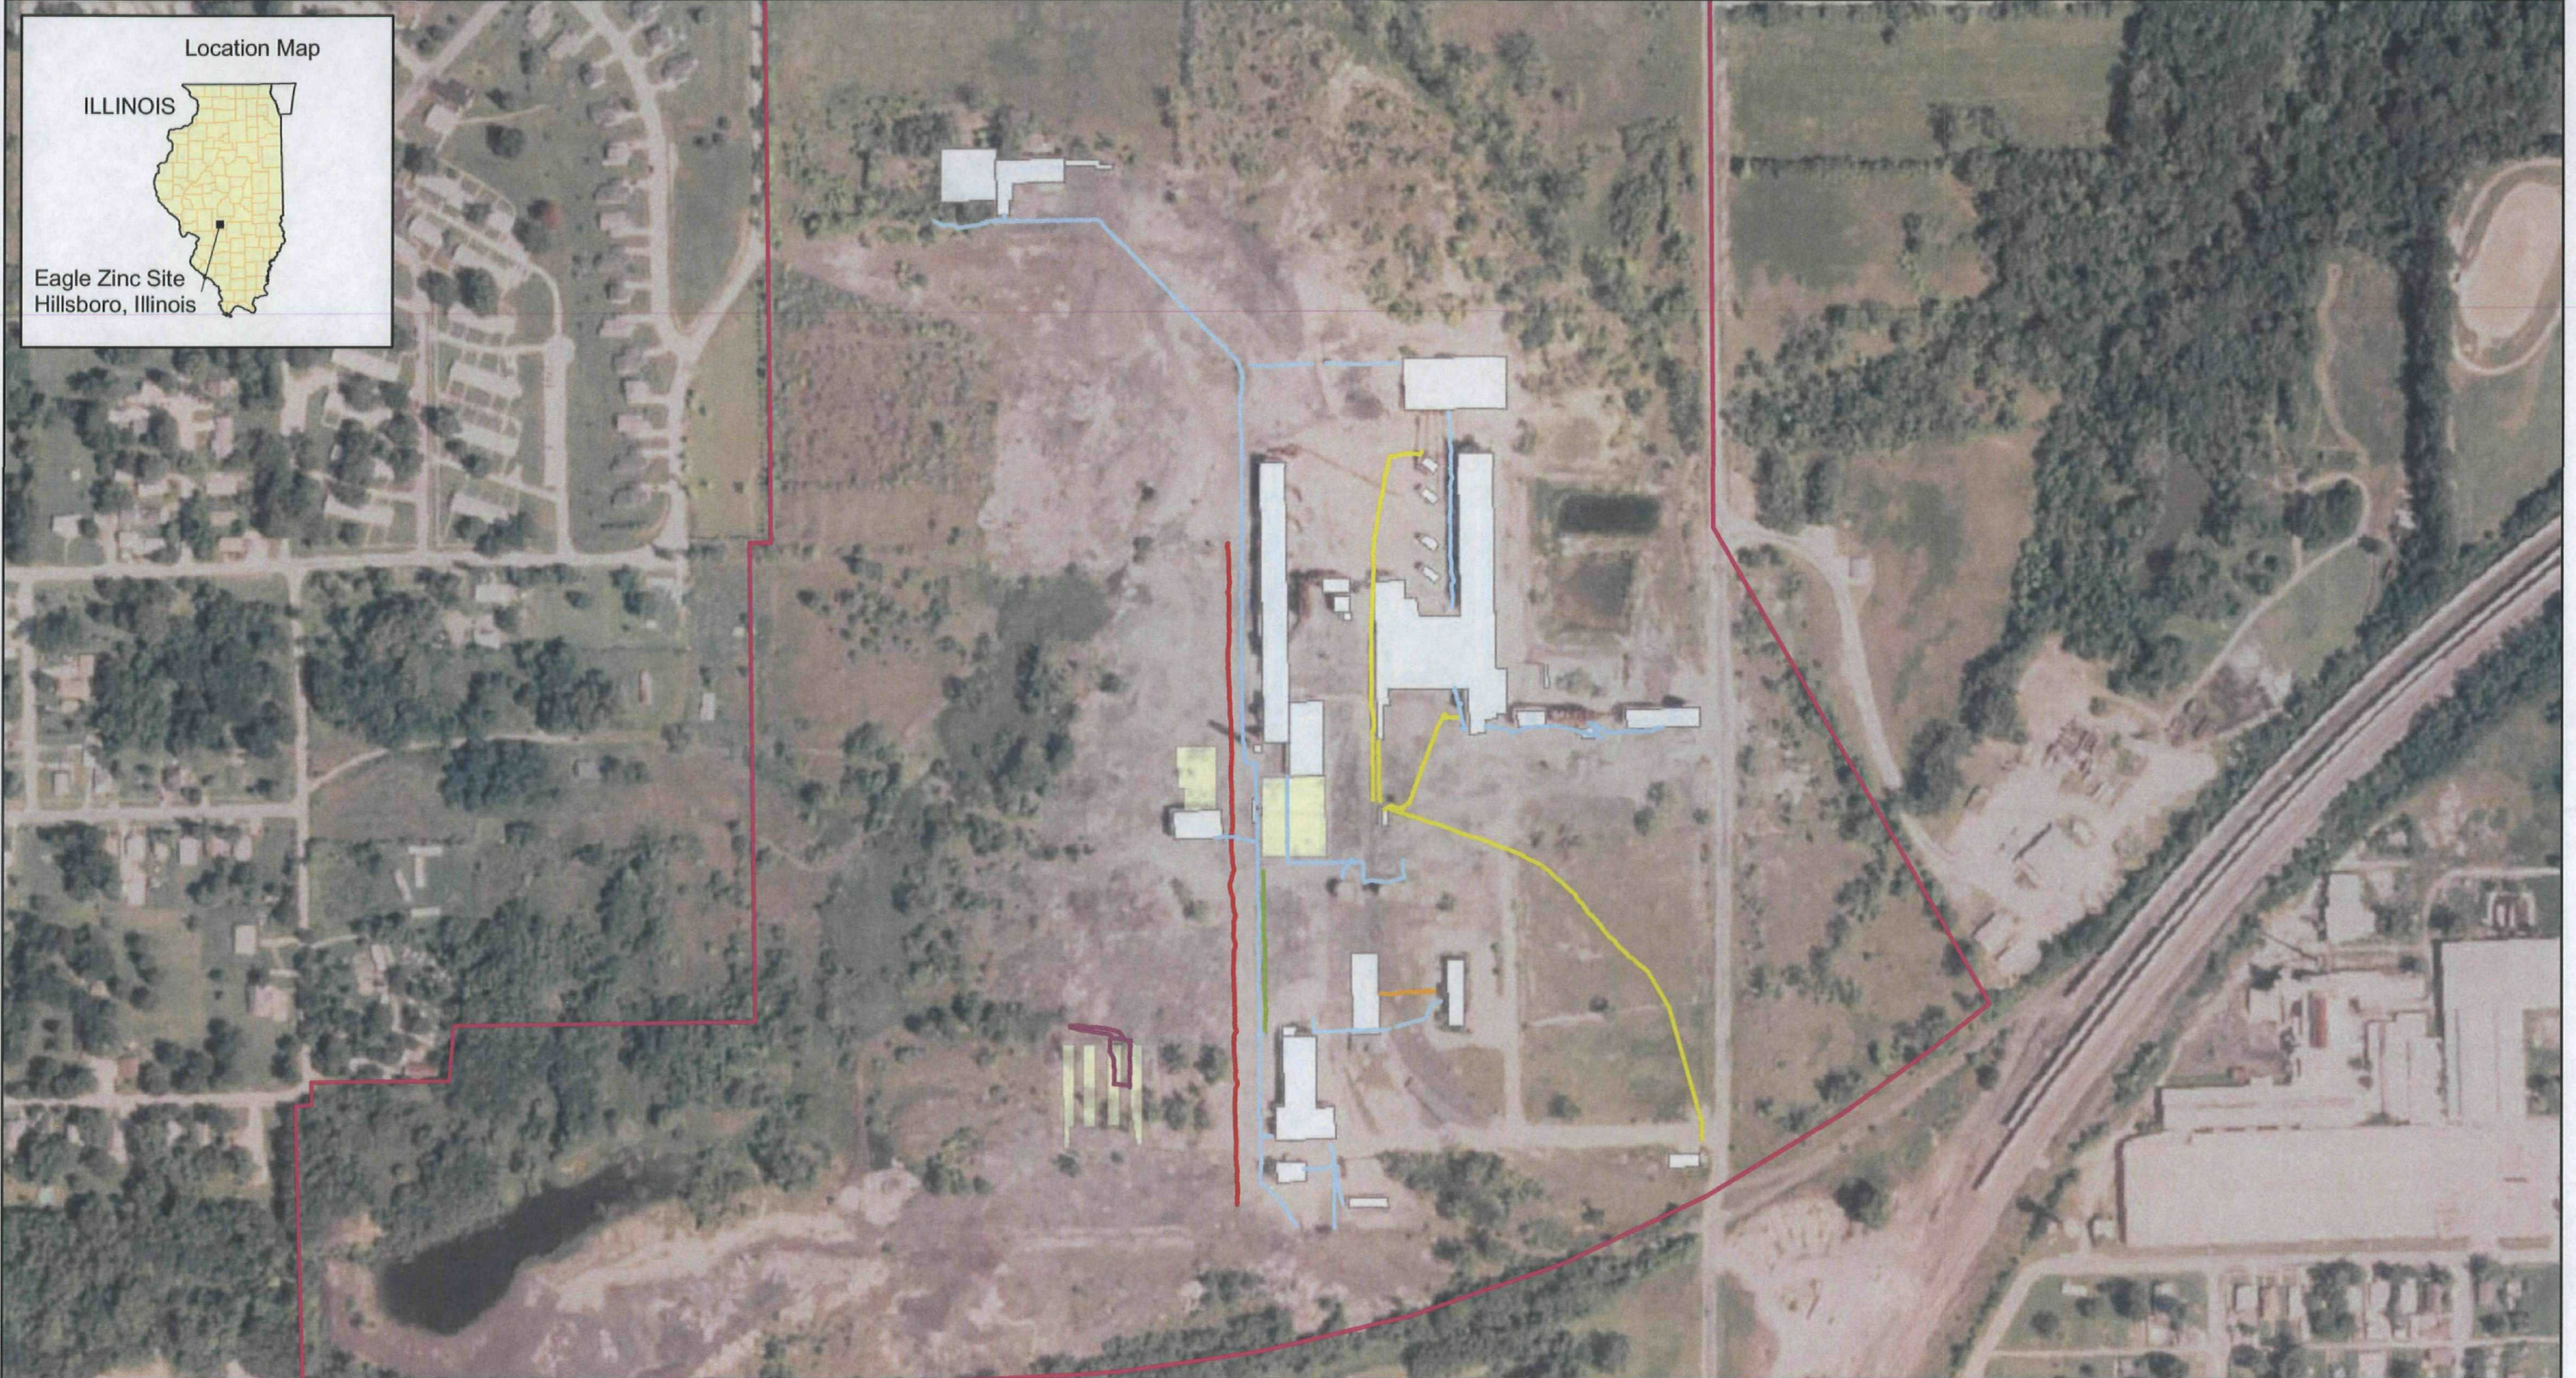
The underground stormwater sewer piping that runs across the site is partially collapsed. Based on discussions with the construction staff at the neighboring Lumberyard, the outfall to the creek along the southern border of the property was capped off and covered during reconstruction and placement of rip-rap along the creek embankments.

This former storm sewer piping is not fully functional, and the area that has collapsed will be filled in with dense graded aggregate to match the surrounding grade and compacted.

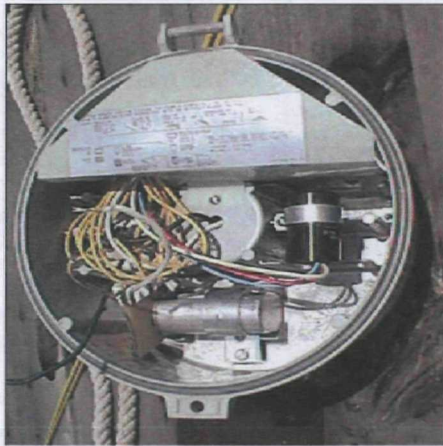
Some lamp fixtures and other electrical equipment will have a small capacitor. PCB small capacitors in pre-1980 equipment are commonly encountered during electrical work and demolition. These are often found in electrical equipment such as lamp fixtures (high-intensity discharge lamps) and air conditioners. All small capacitors must be removed, examined for No-PCB label and managed as PCB waste if the No PCB designation is not shown.

*Fixture with Small Capacitor In-Place*

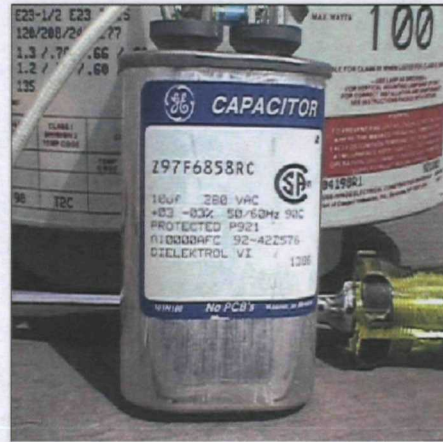
If managed separate from ballasts, small capacitors (even non-PCB liquid-filled small capacitors) will be contained separately, and not put in general trash or scrap metal receptacles. Leaking capacitors will be placed in a container marked PCB-containing waste.

*Remove and Examine the Small Capacitor.  
Note: "No PCBs" On Label.*

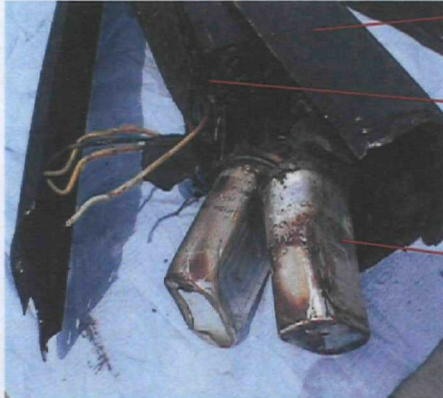
Typical light ballasts

Potting material

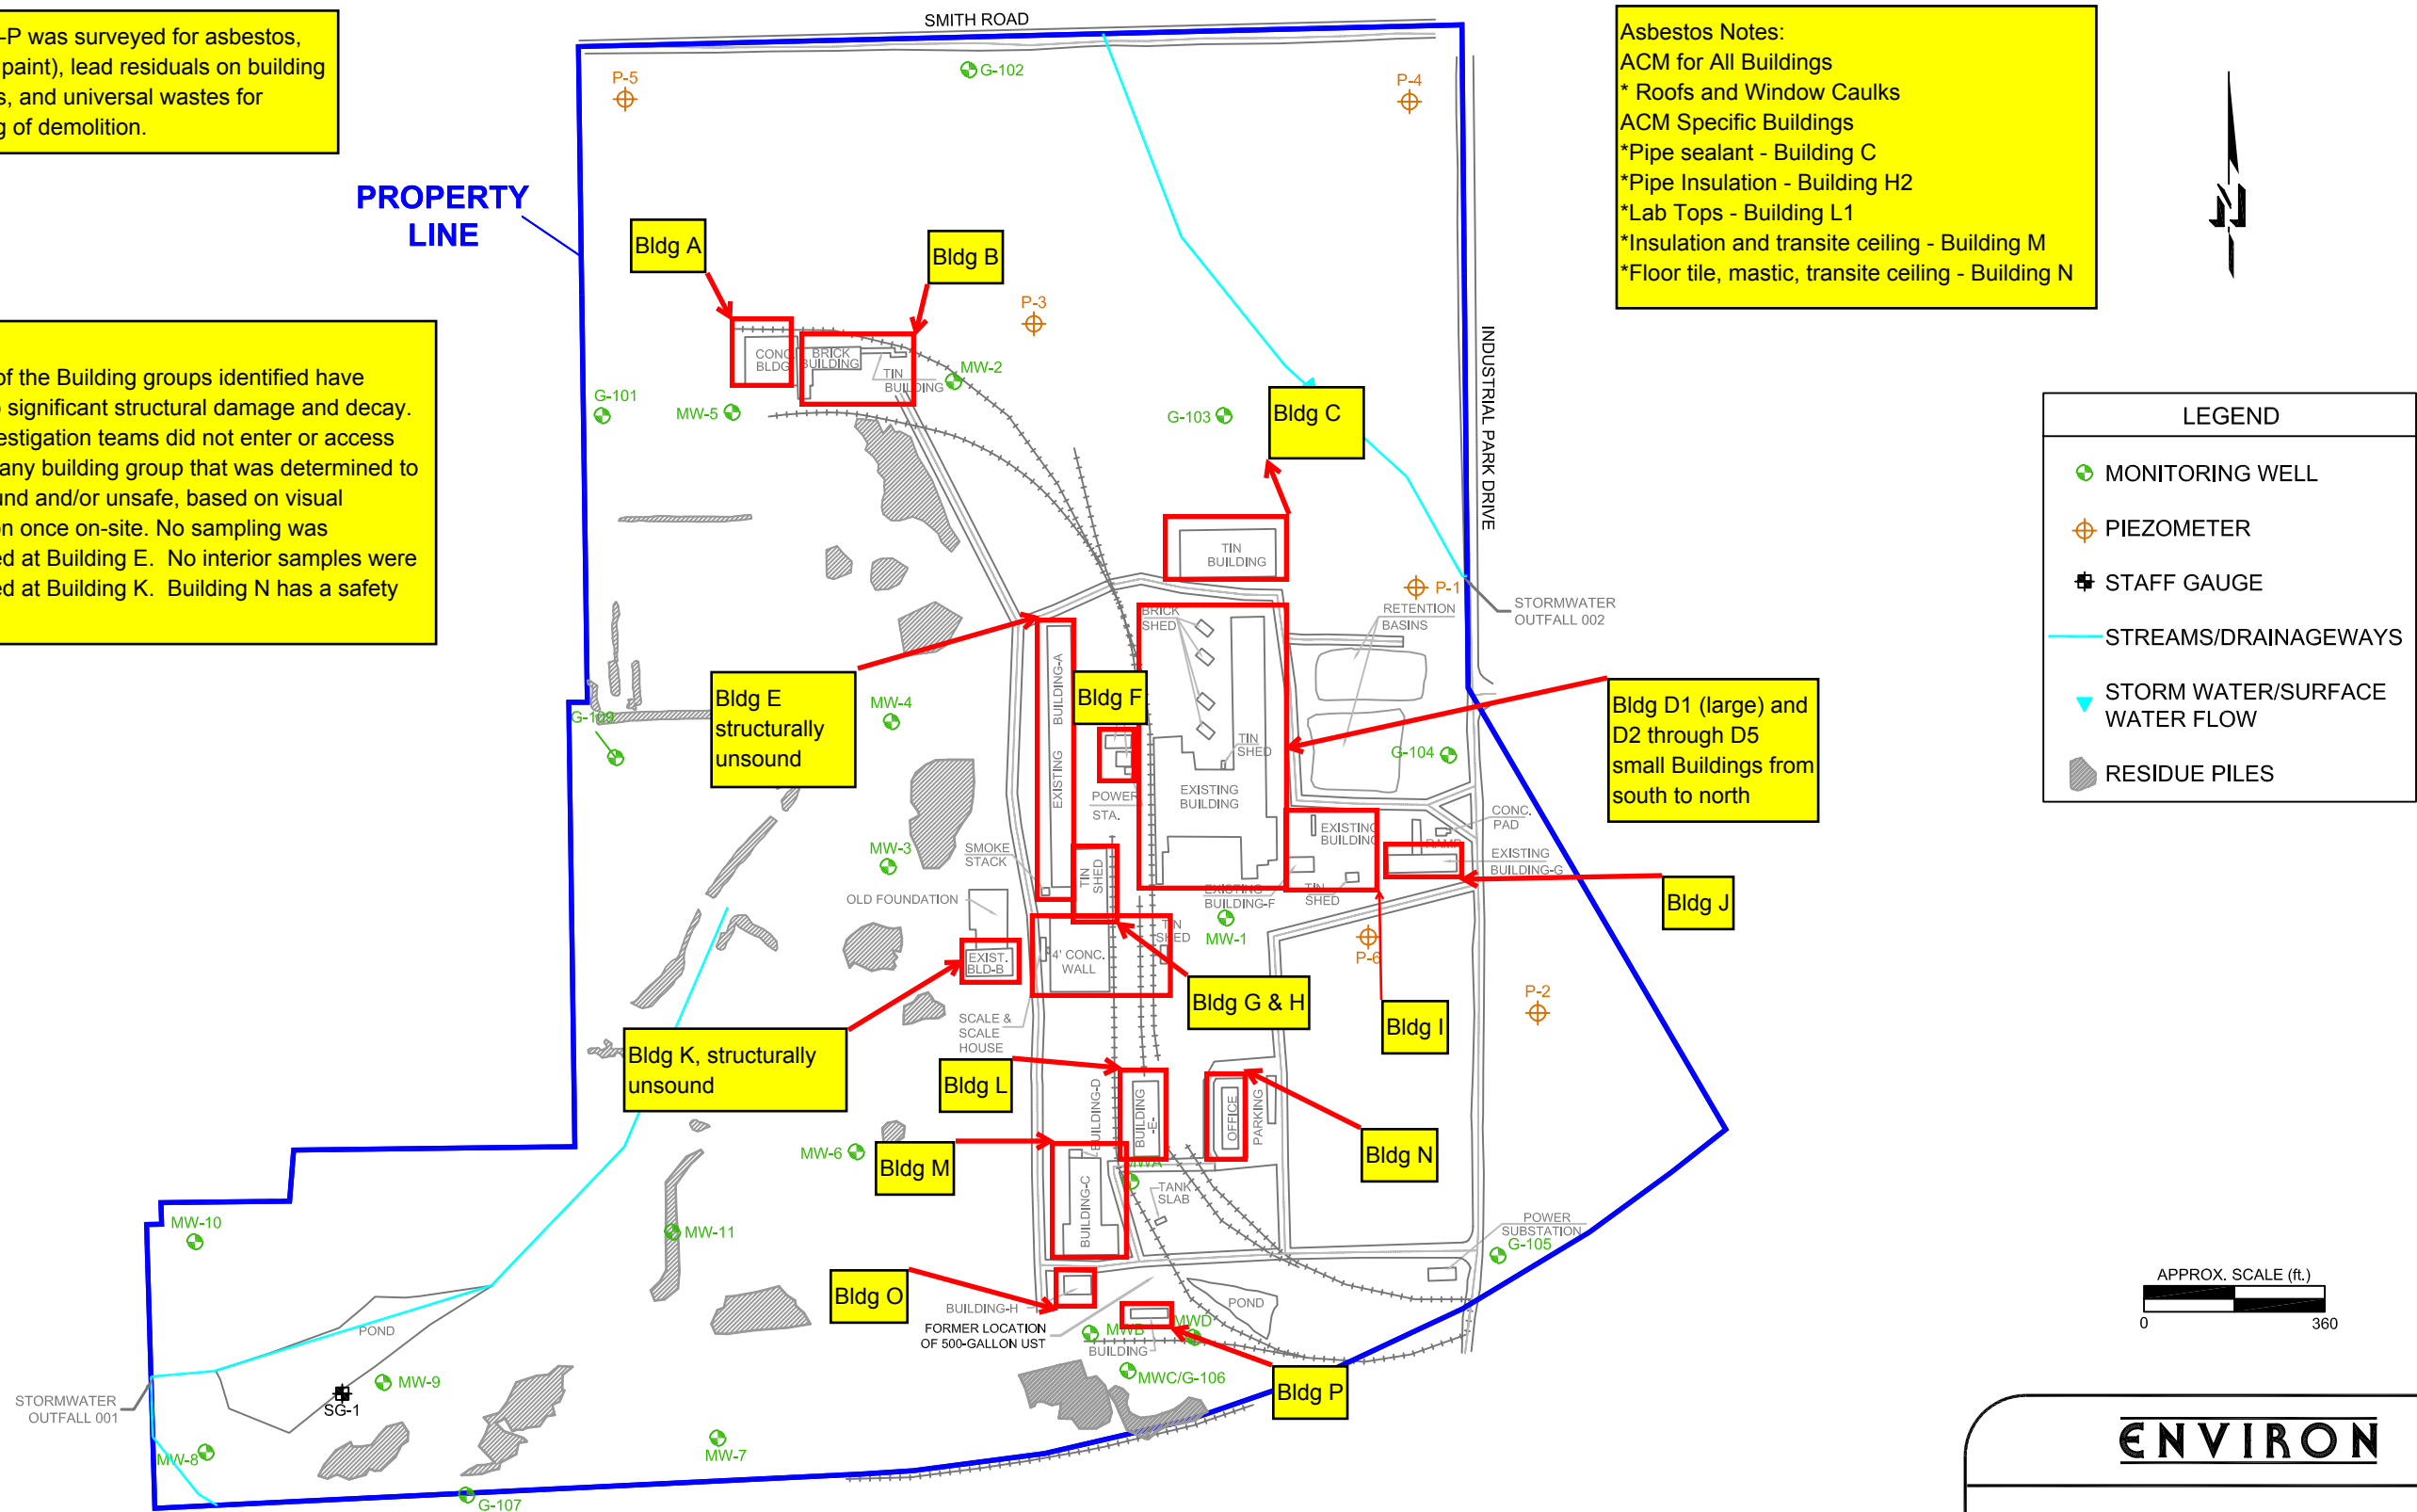
SITE LAYOUT MAP  
EAGLE ZINC  
HILLSBORO, ILLINOIS

**NOTE:**  
Several of the Building groups identified have limited to significant structural damage and decay. Field investigation teams did not enter or access areas of any building group that was determined to be unsound and/or unsafe, based on visual evaluation once on-site. No sampling was conducted at Building E. No interior samples were conducted at Building K. Building N has a safety concern.

**Asbestos Notes:**  
ACM for All Buildings  
\* Roofs and Window Caulks  
ACM Specific Buildings  
\* Pipe sealant - Building C  
\* Pipe Insulation - Building H2  
\* Lab Tops - Building L1  
\* Insulation and transite ceiling - Building M  
\* Floor tile, mastic, transite ceiling - Building N

A site map showing the location of the buildings at the Eagle Zinc Site is shown in Figure 2-1. The building designations were developed as part of the hazardous material survey. Photographs of the buildings are presented in Appendix B. The buildings (and all equipment within the buildings) scheduled for demolition are shown in Table 2-1.

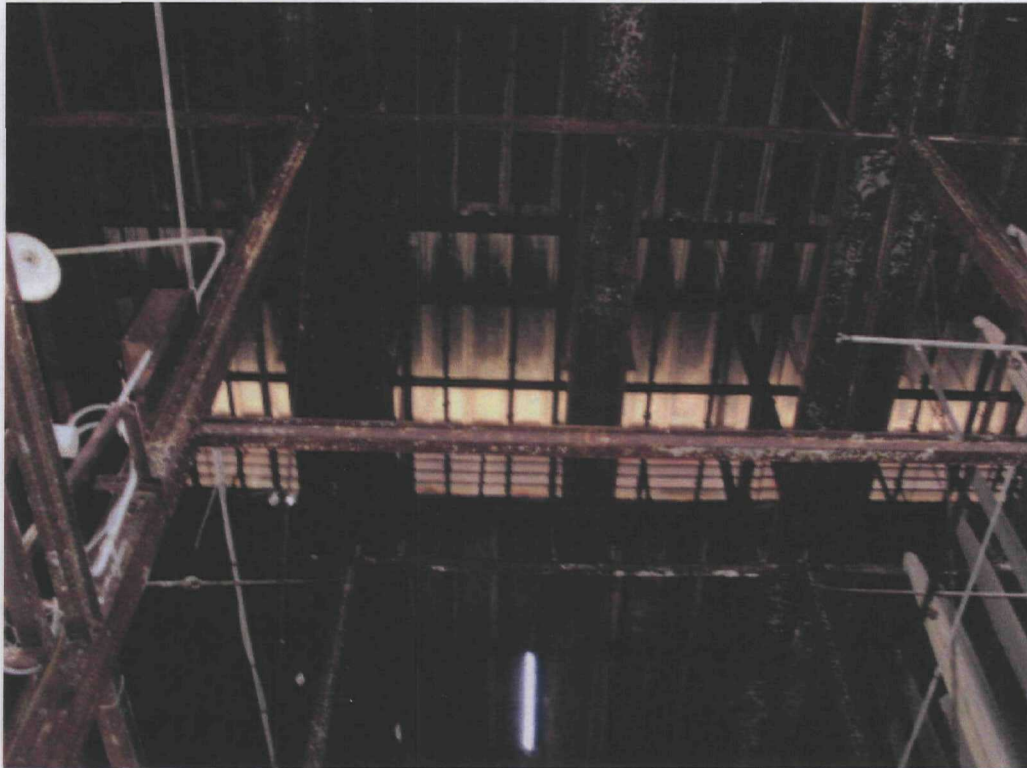
**Photo 11:** Structural steel within Building D

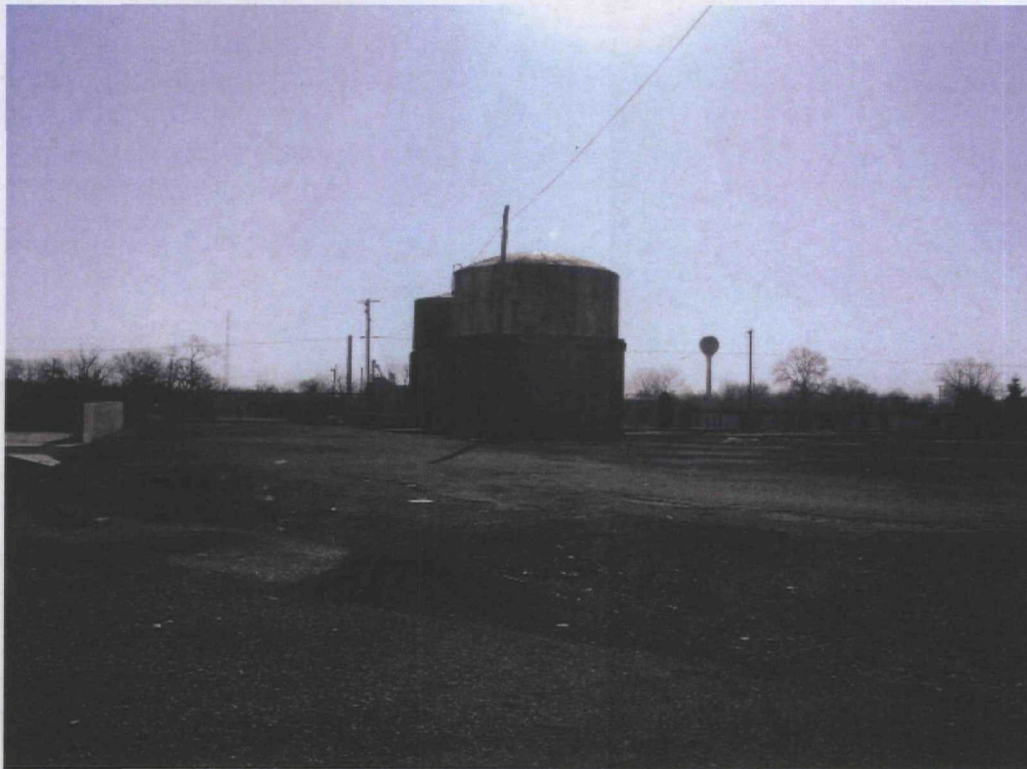
**Photo 43:** Two ASTs on concrete foundations.

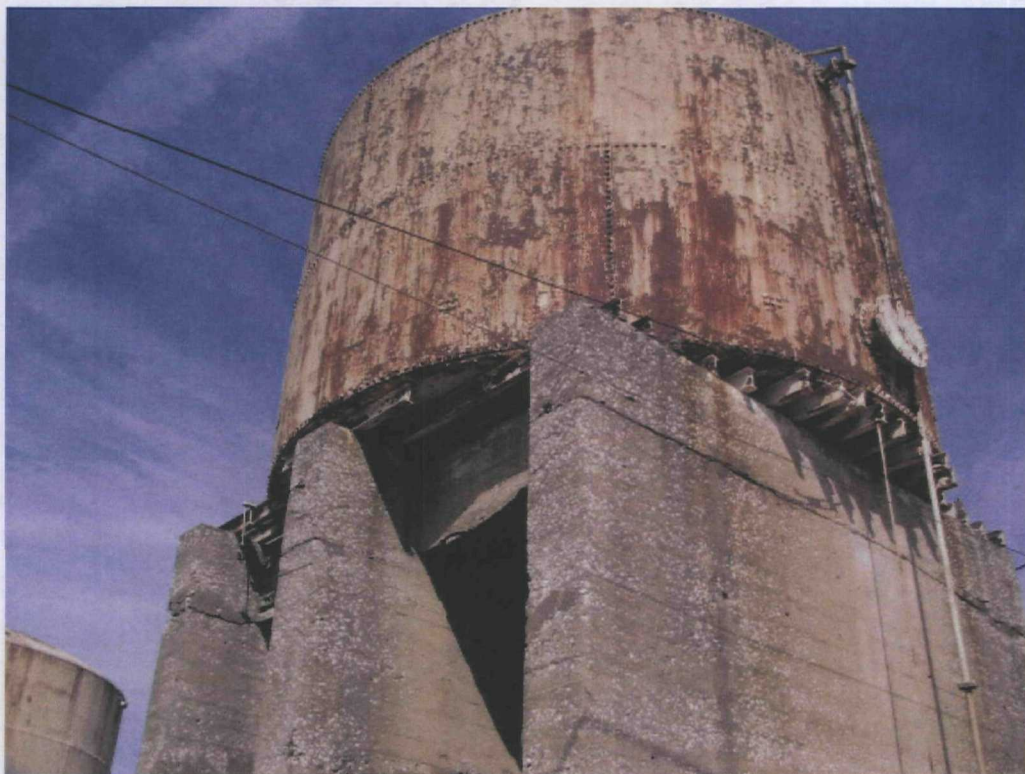
**Photo 44:** Close-up of one AST on concrete foundation.

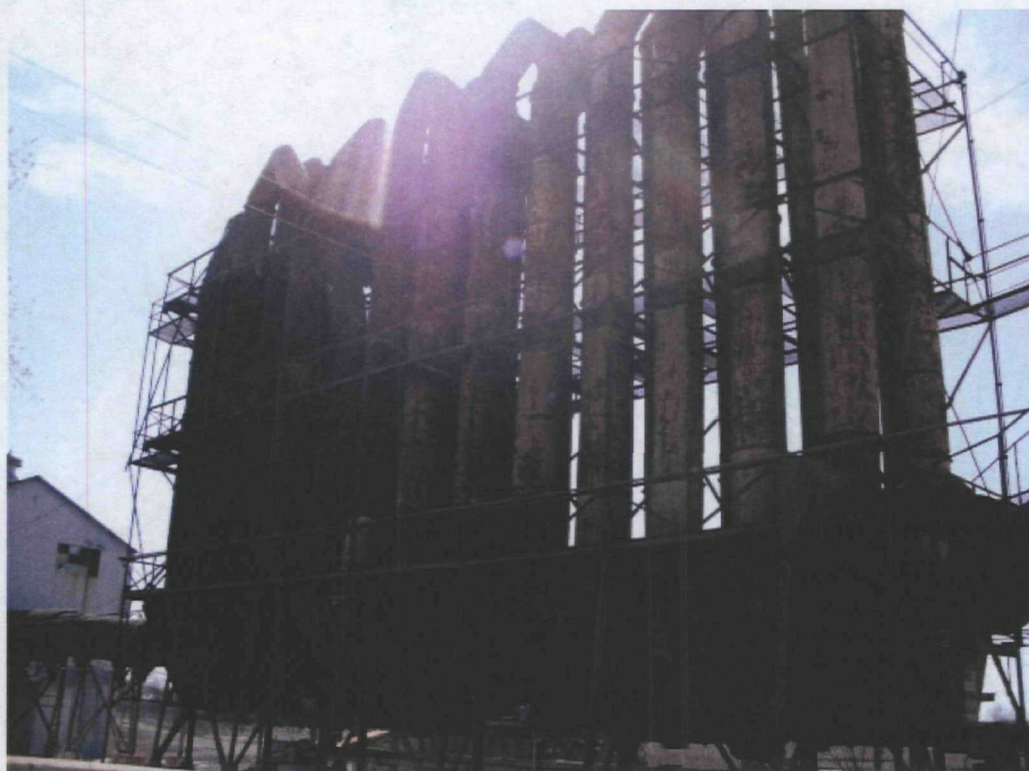
**Photo 45:** Cooling Tower

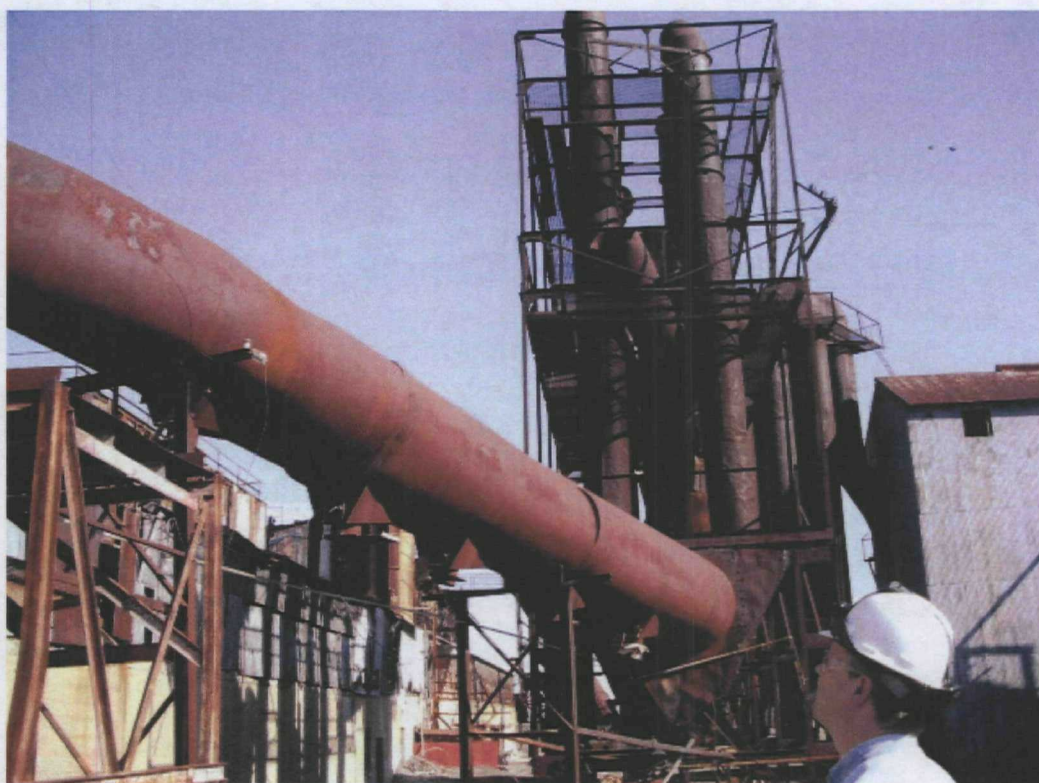
**Photo 46:** Site Duct Conveyor between Main Rotary Kiln Building and Fan Buildings

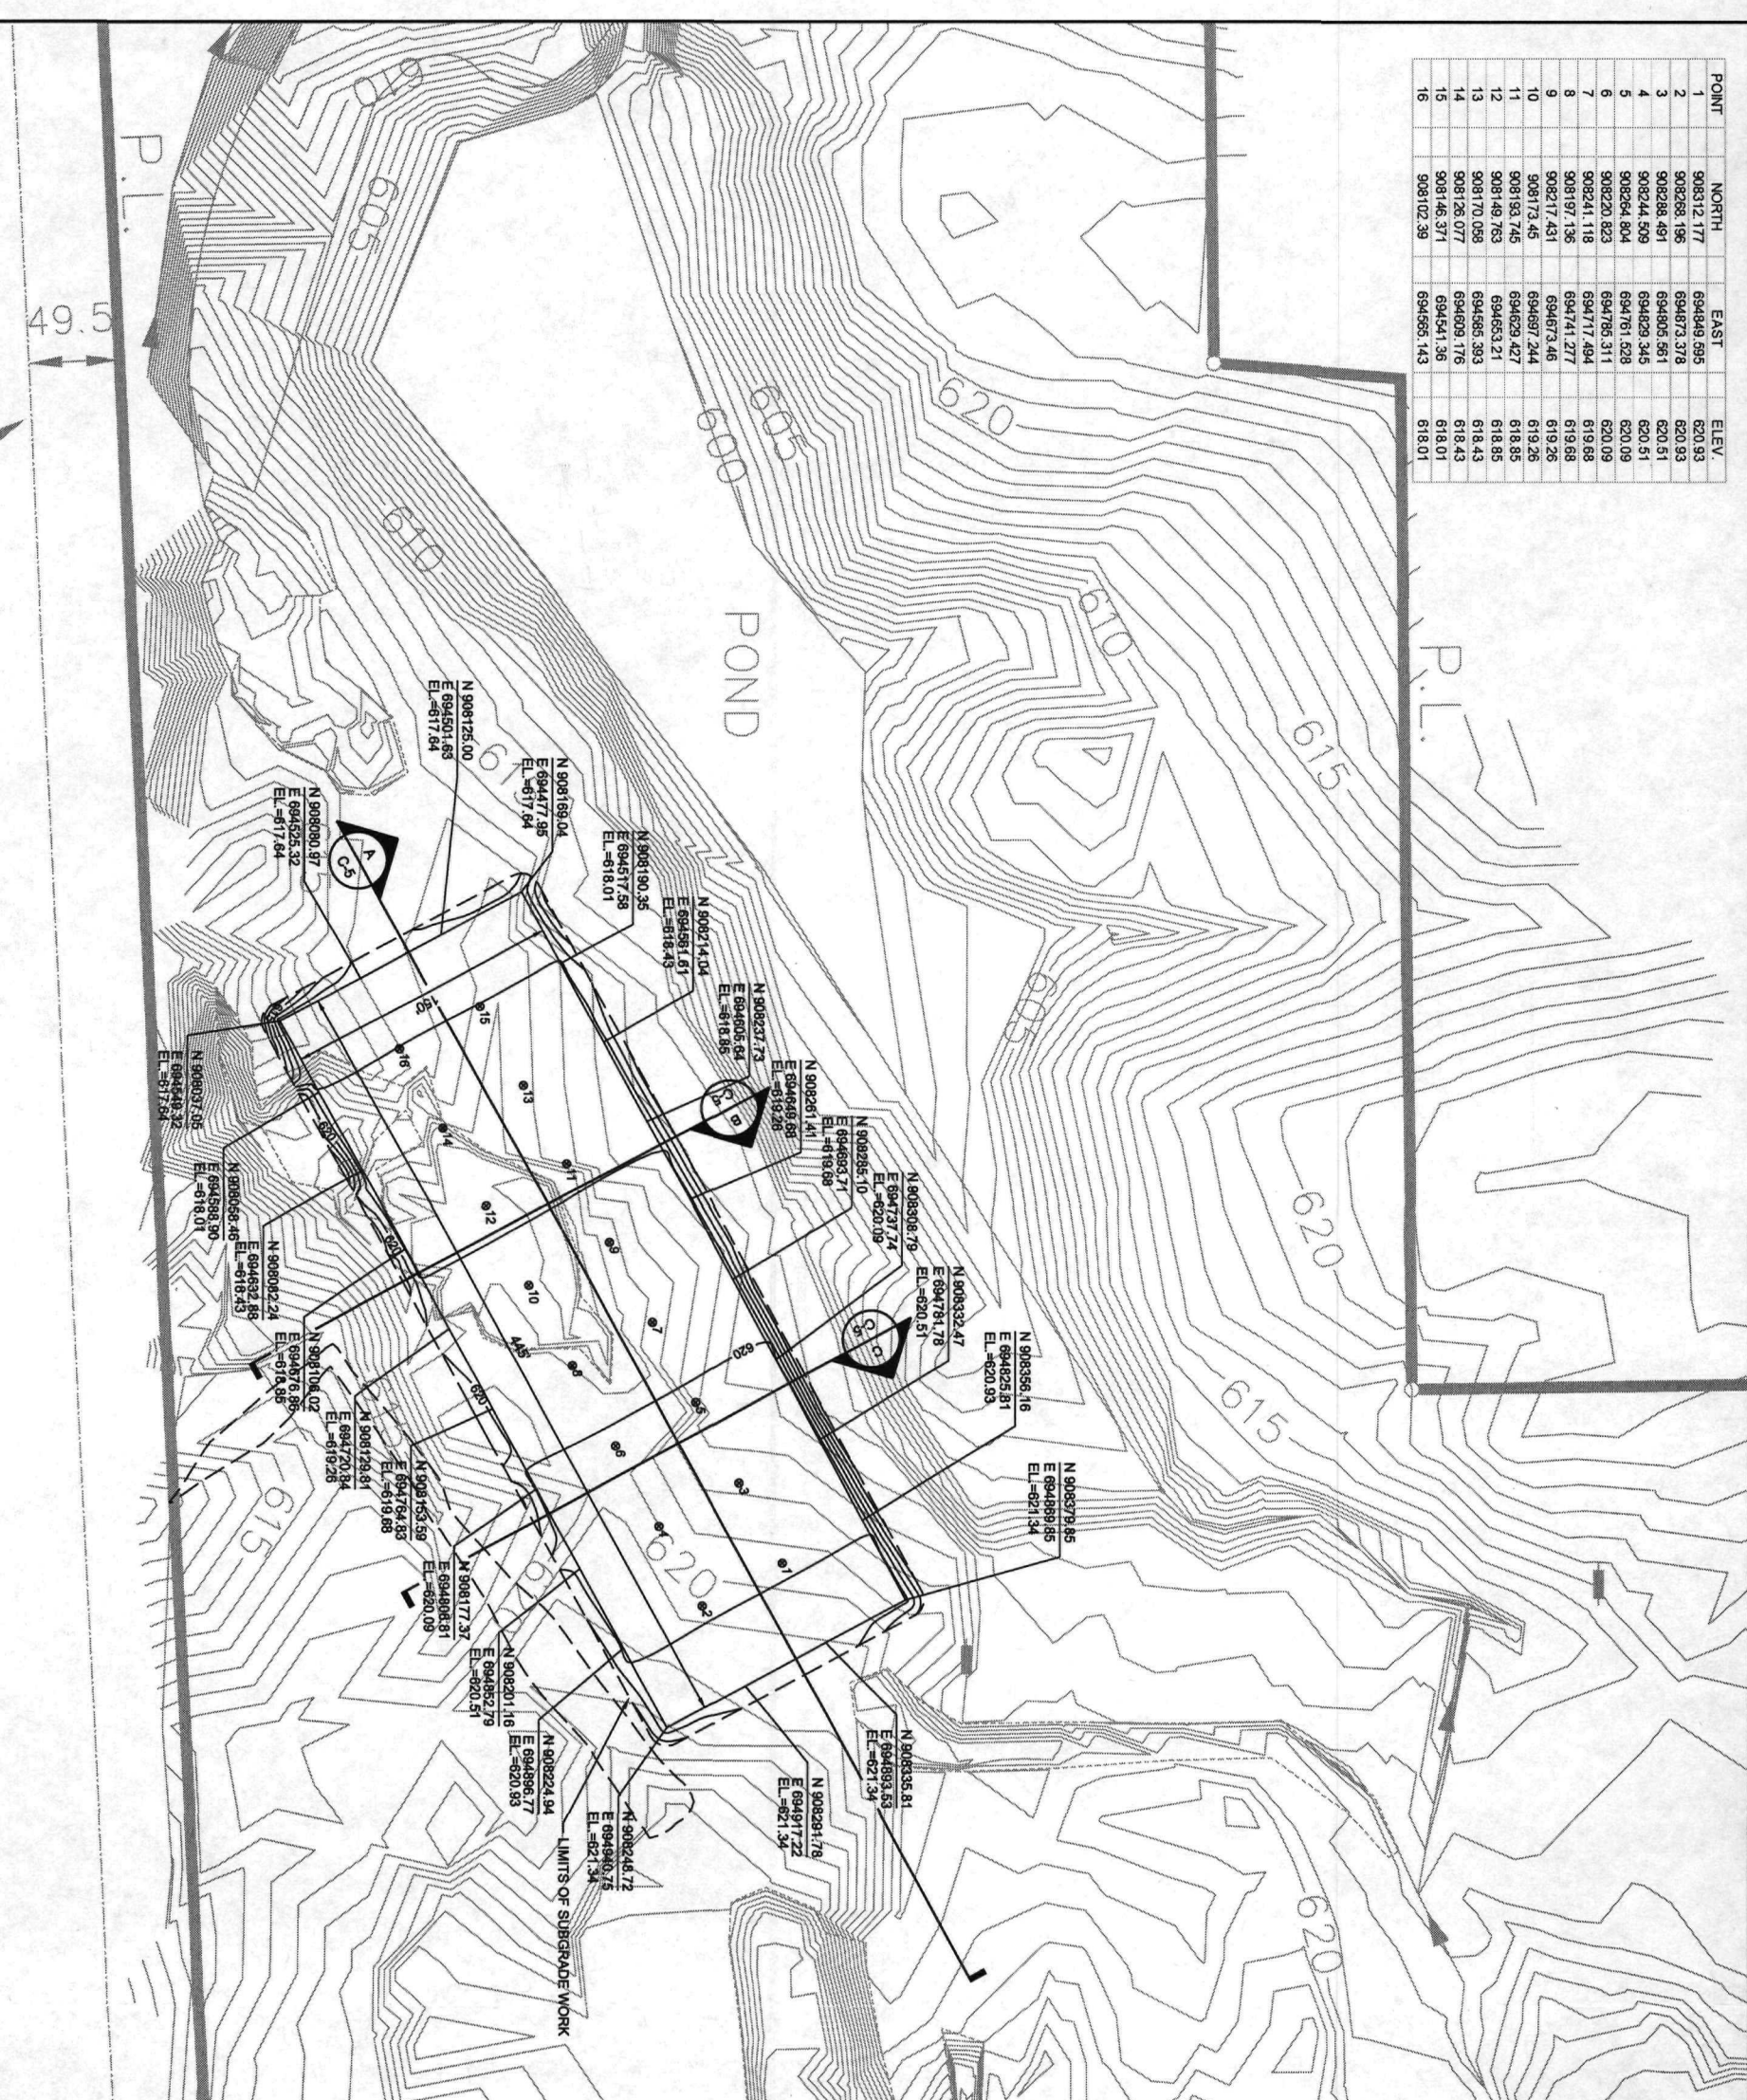
SUBGRADE PREPARATION  
\*\* Total Cut = 2595 Cubic Yards \*\*  
\*\* Total Fill = 2336 Cubic Yards \*\*  
\*\* Area = 8750 Sq Yards \*\*  
\*\* Balance = 259 Cubic Yards \*\*  
NOTE:  
QUANTITIES FOR SUBGRADE PREPARATION  
WERE ESTIMATED FOR COST ESTIMATING  
PURPOSES.

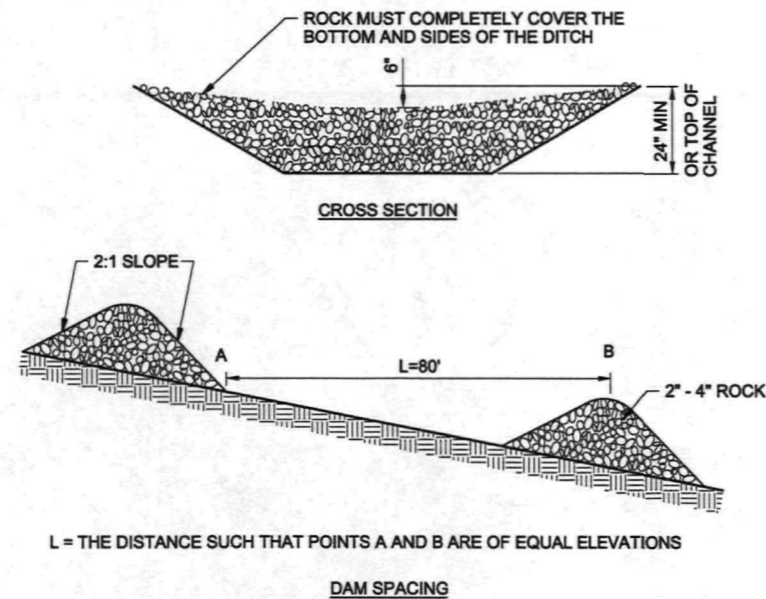
1. ANY SEDIMENT DEPOSITION OF MORE THAN 0.5 FEET SHALL BE REMOVED SO THAT THE CHANNEL IS RESTORED TO ITS DESIGN CAPACITY.
2. THE CHANNEL SHALL BE EXAMINED FOR SIGNS OF SCOURING AND EROSION OF THE BED AND BANKS. IF SCOURING OR EROSION HAS OCCURRED, AFFECTED AREAS SHALL BE PROTECTED BY RIP-RAP OR AN EROSION CONTROL BLANKET OR NET.

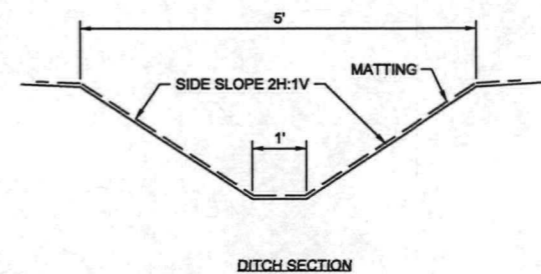
1. SLOPE SURFACE SHALL BE SMOOTH BEFORE PLACEMENT FOR PROPER SOIL CONTACT.
2. DO NOT STRETCH BLANKETS/MATTINGS TIGHT, ALLOW THE ROLLS TO MOLD TO ANY IRREGULARITIES.
3. STAPLE PATTERN AS PER MANUFACTURER'S RECOMMENDATIONS.
4. FOR SLOPES LESS THAN 3:1, ROLLS MAY BE PLACED IN HORIZONTAL STRIPS.
